QUINQUENNIAL INSPECTION REPORT

ST MARY, POLSTEAD, SUFFOLK

Inspecting Architect: Philip Orchard
Date of inspection: 20th April 2023

PEO/cmC896/1
21st April 2023

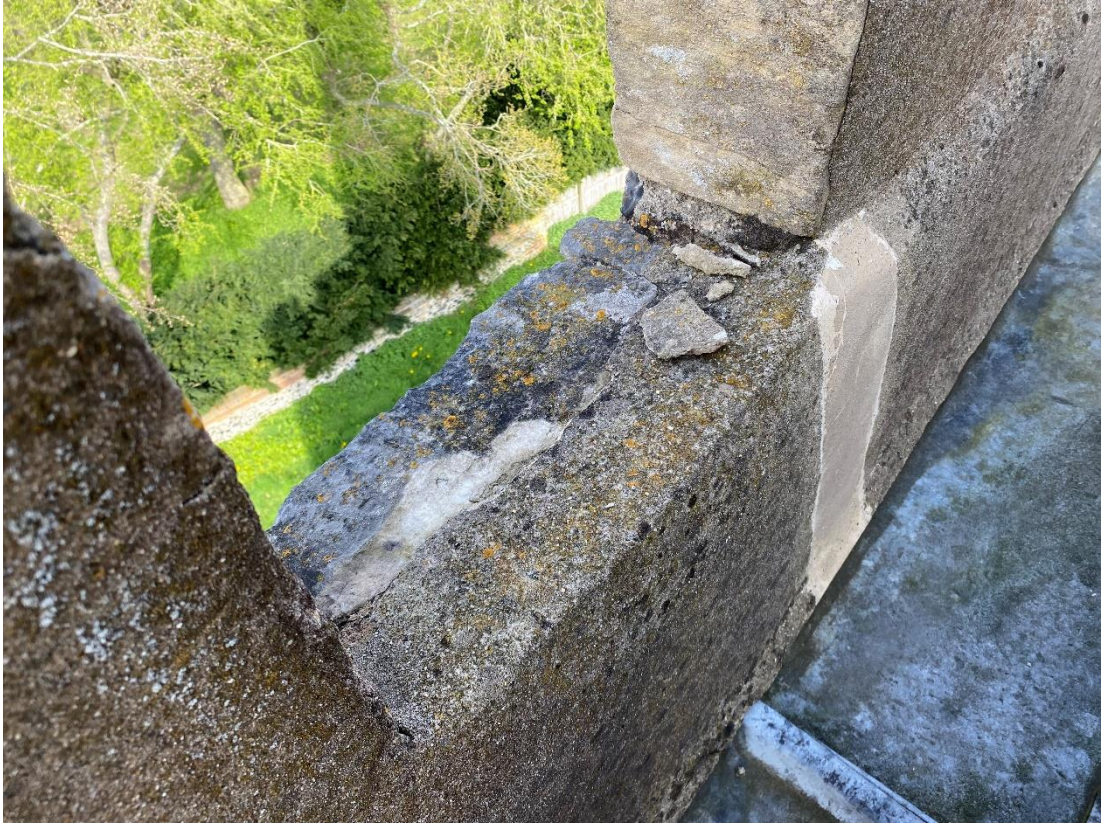
7.4 Tower west parapet embrasure

ITEM	E	---
7.4	The flashings are satisfactory. On the east and west faces, the gutter leadwork is carried up under the rendered drip moulding instead of a flashing. The stone copings are soundly bedded. The rendered parapet backs are in reasonable order. Remake the flaunching over on west embrasure to prevent frost levering the stone below loose.

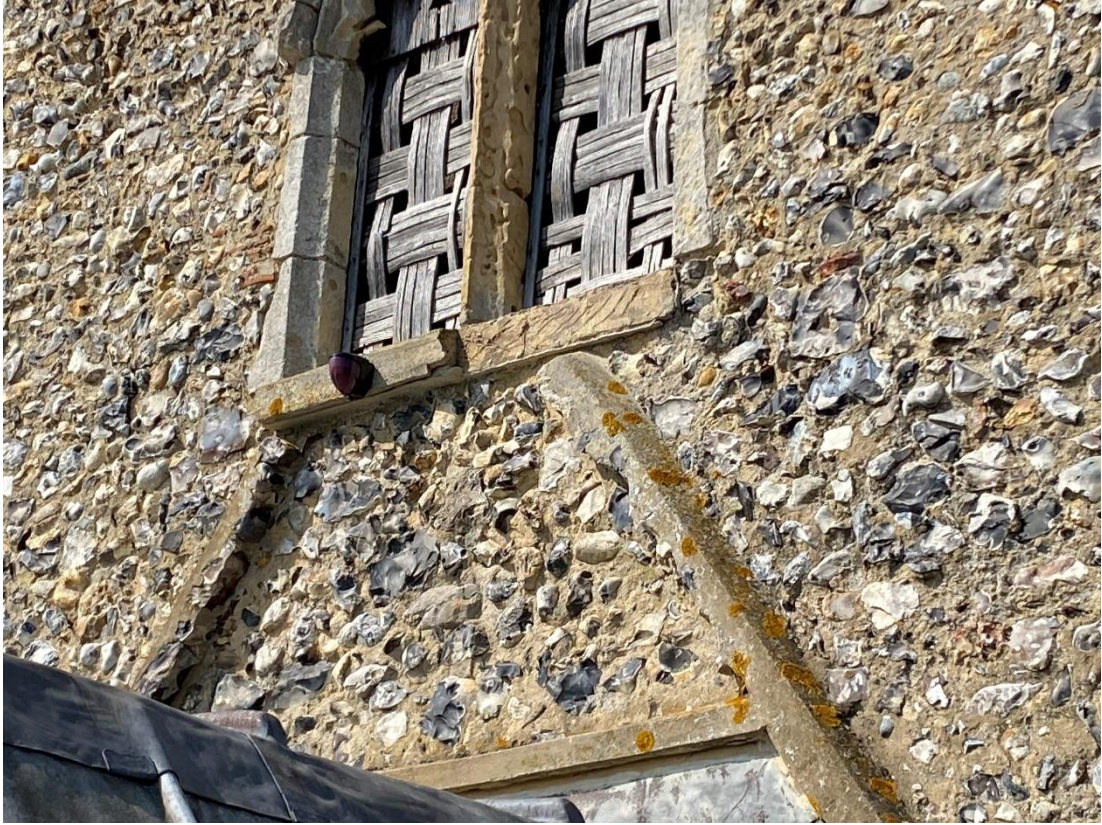
9.5 East belfry light cill

9.4	The stonework of the mullion is decaying, being quite pitted, but not yet in need of renewal.		
		ITEM E	---
9.5	The rendered parts of the cill are decaying but there are no problems yet; unless the decay affects the roof alarm sensor. Keep under review.

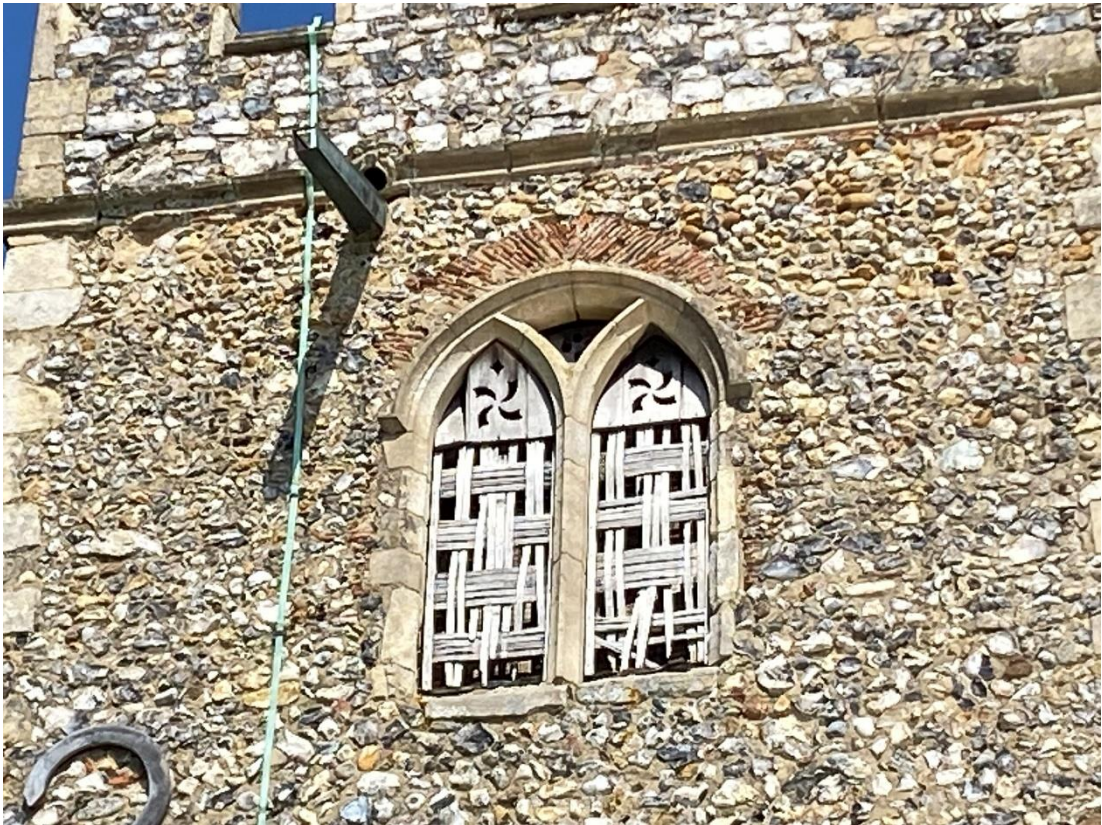
9.6 South belfry light

PRIORITY	BUDGET COSTS
	B/F	800 - 1,200
9.6	South belfry light: the stonework is satisfactory. The lattices are decaying at the cill level. Renew in association with the west light repairs.

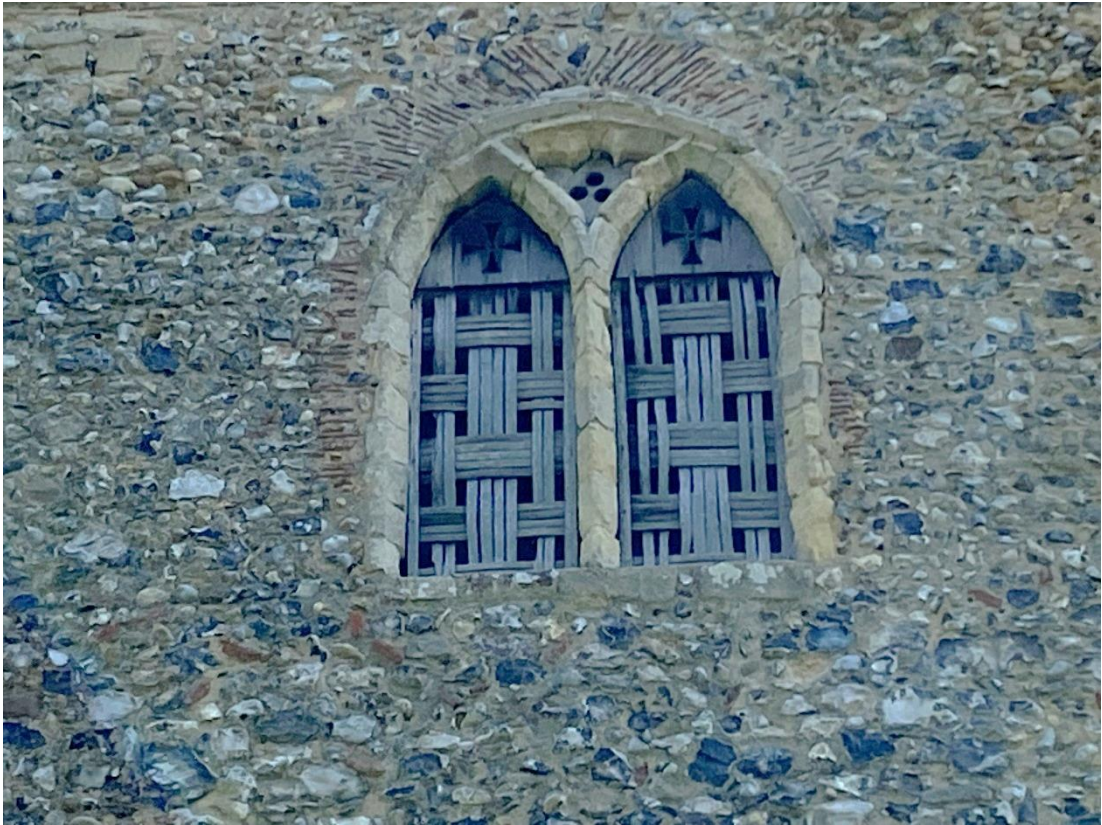
9.7 West belfry light

ITEM C	800 - 900
9.7	Tower west belfry light: the lattices are satisfactory. The stonework is quite decayed generally and significant renewals will be needed.

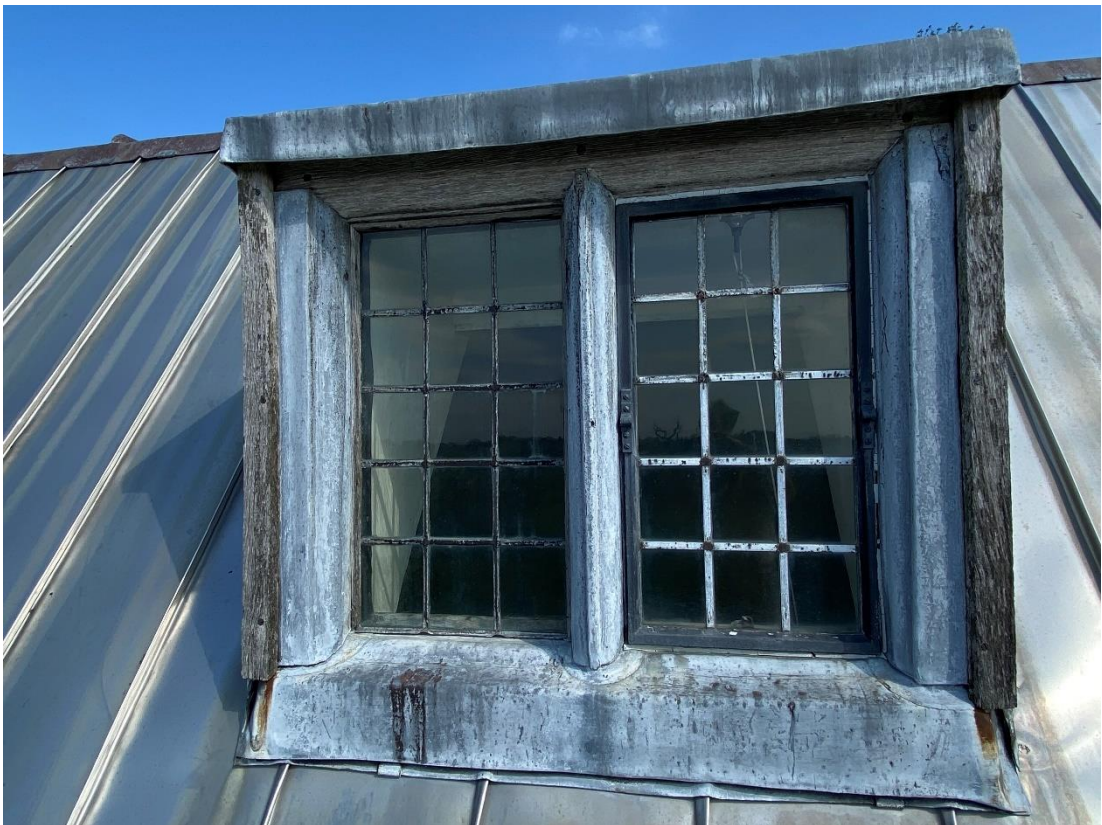
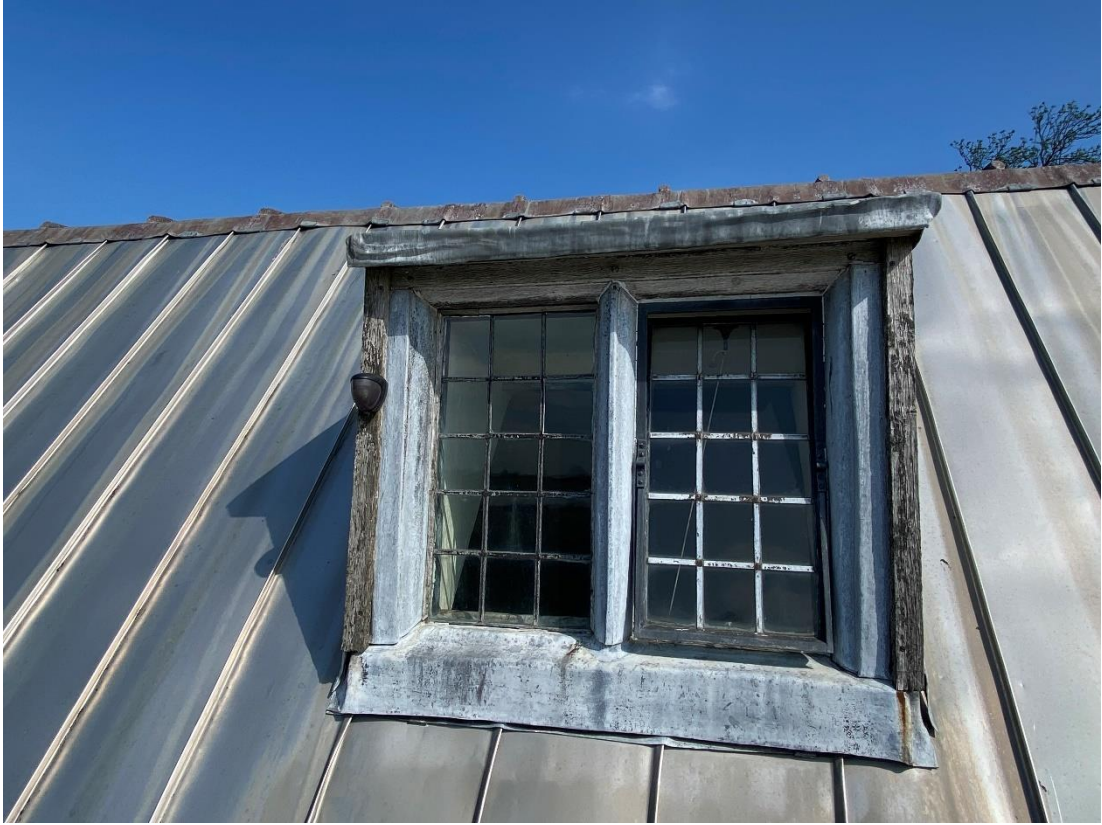
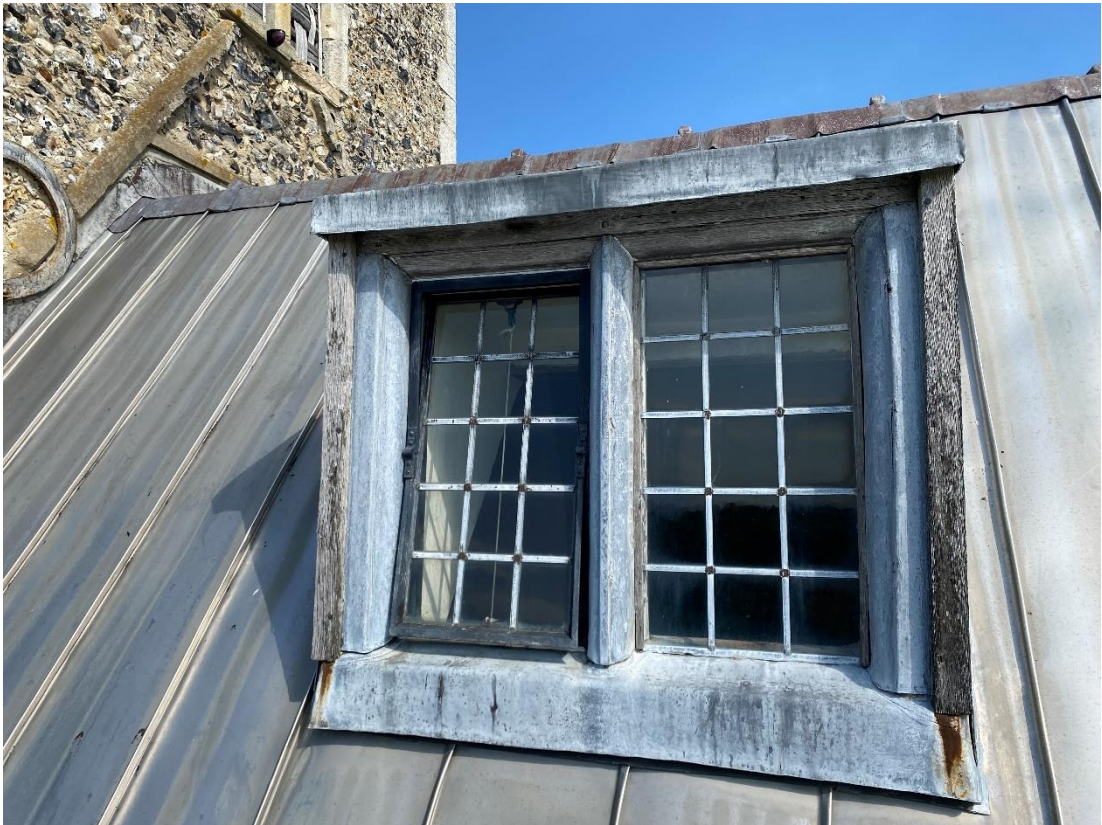
9.12	Nave south windows: three dormer windows: for the general description of the dormers see 7.7 above. Each window comprises one fixed light and one opening light, cord operated from below, with timber frames (partly lead clad) and rectangular quarries in lead comes with internal saddlebars.	
	The condition of all three windows is satisfactory seen from the south aisle roof. The easternmost window opening light has seized shut and cannot be opened: release and renew the cords. Repaint the ironwork of the three windows and oil or lime the timberwork.

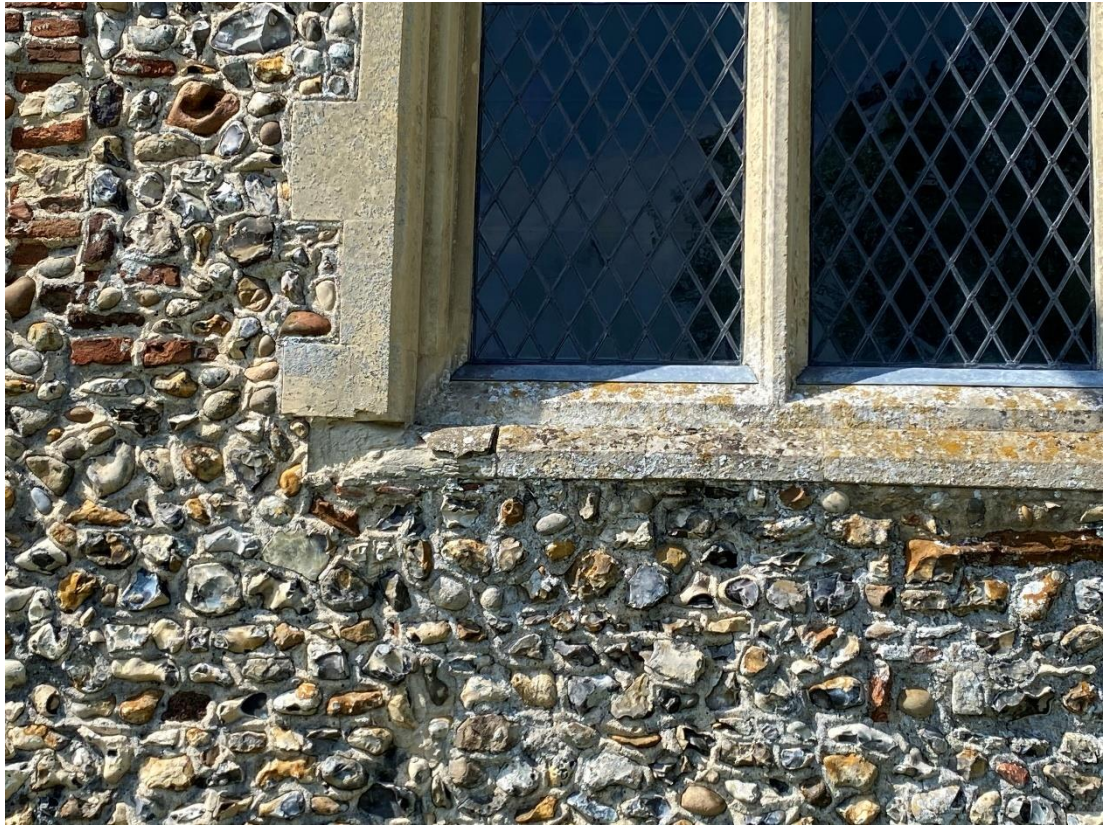
9.15 Window CE

9.15 **Chancel east window CE:** three lights with stone cill, mullion, jambs, tracery, head (no labelmould); glazing of tinted diamond quarries in lead comes with internal saddlebars; lead condensation trays at the cills. The condition of all is satisfactory, except for long-term decay of the cill stonework especially at the south end. Stone renewals will be needed in this quinquennium.

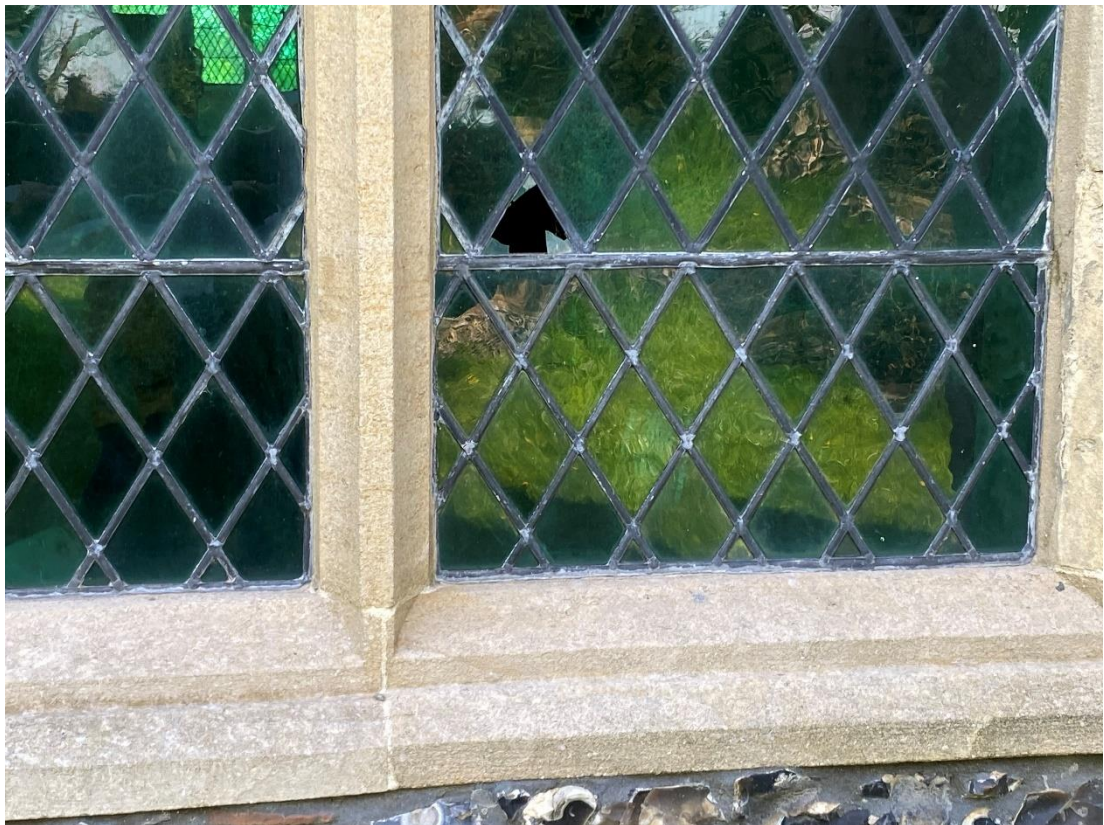
9.25 Window NAW

- 9.23 **Window NAW:** three lights with stone cill, mullions, jambs, tracery, head and labelmould; glazing of tinted green diamond quarries in lead comes with internal saddlebars. The stonework condition is reasonable. The glazing is bowing and may need to be releaded in the next quinquennium.

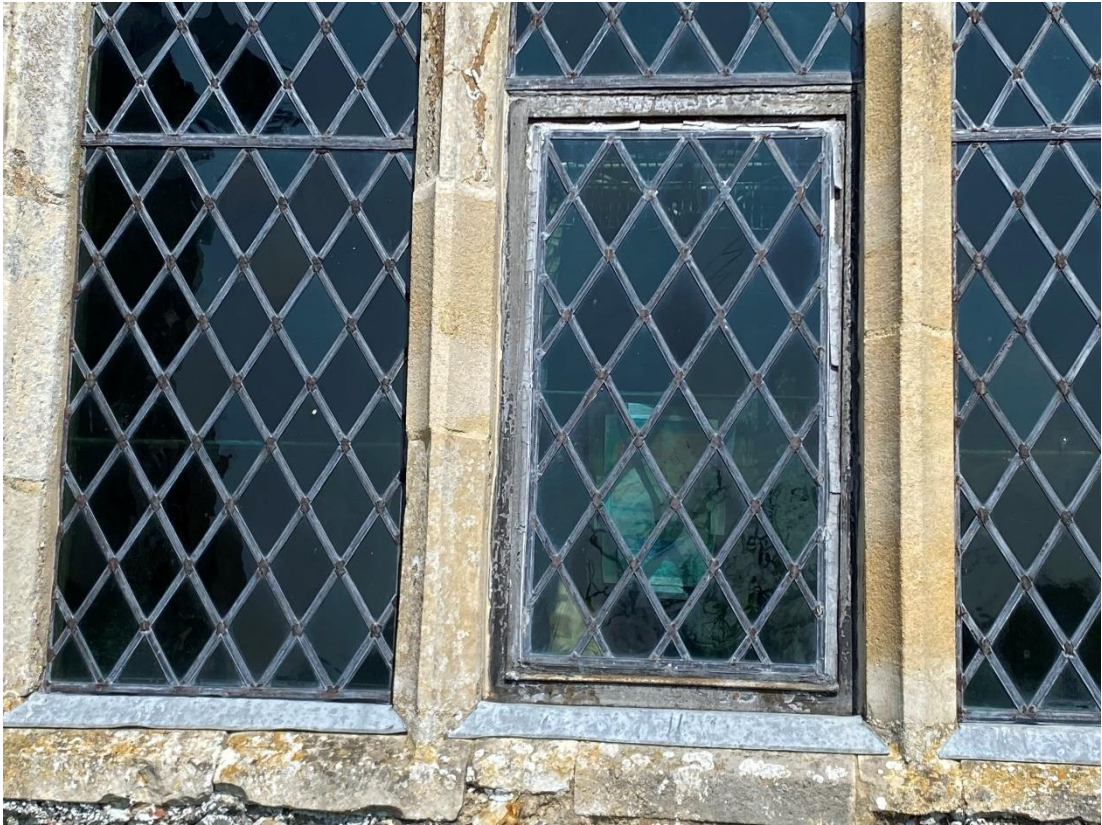
9.31 Window SAS2

9.30 **Window SAS2:** three lights with stone cill, mullions, jambs, tracery, head and labelmould; glazing of tinted diamond quarries in lead comes with internal saddlebars; iron framed opening light in the centre lancet at cill level. The glazing condition is reasonable. The stonework has long-term decay in the jambs. The ironwork requires repainting.

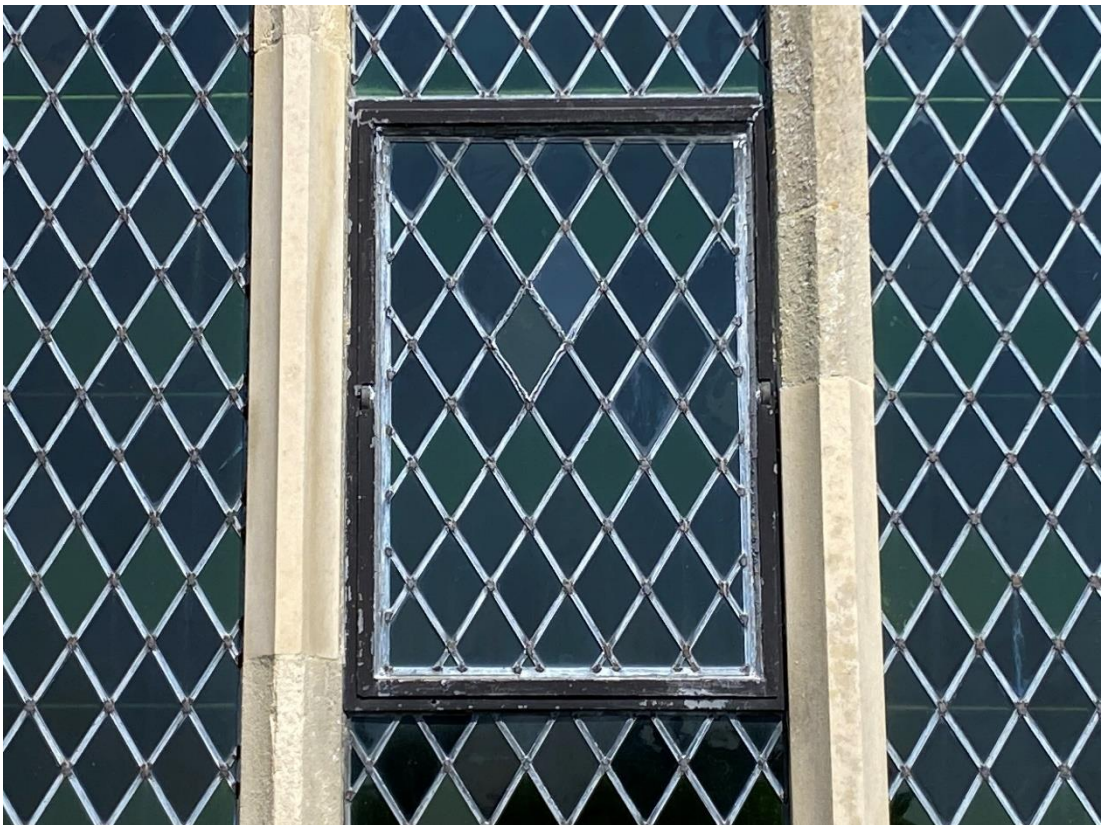
9.32 Window SAS3

9.31 **Window SAS3:** three lights with stone cill, mullions, jambs, tracery, head and labelmould; glazing of tinted diamond quarries in lead comes with internal saddlebars; iron framed opening light partway up the centre lancet. The condition is satisfactory, but repaint the ironwork.

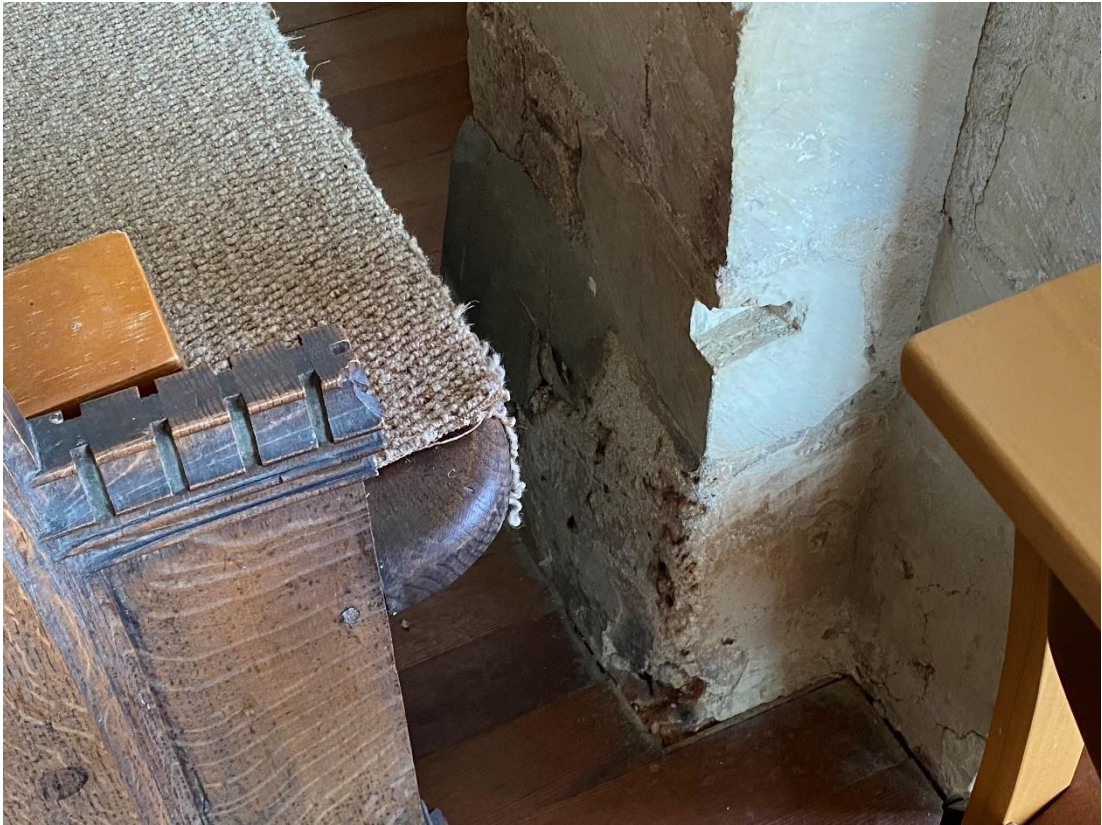
11.10 Nave south pier

- 11.10 The plastered ceiling is in reasonable order seen from ground level: decorations are satisfactory. There is evidence of old cracking but it seems to have been filled by the last redecoration and has not obviously reopened. The walls are generally plastered and limewashed, with three small patches of wall painting surviving on the north wall; former clerestorey windows have stone/brick jambs and arched brick heads, which are exposed in the internal walls. The condition is generally good: there is minor water streaking on the east wall under the window cill and minor cracking between the wall and ceiling at the west end with some cracking in the north and south walls. As far as can be seen from ground level, the fragments of wall paintings are satisfactory. The stone piers of the arcade and the stone/brick arches over are satisfactory except for a stone missing from the south west corner of the base of the nave westernmost freestanding south pier, which dates from before the current timber floor and is not affecting the structure. Remake the failing cement render (in lime render) on the easternmost south freestanding pier.
